# Section 319

# NONPOINT SOURCE PROGRAM SUCCESS STORY

## Restoring and Stabilizing Stream Channel Improves the Lower Rio Blanco

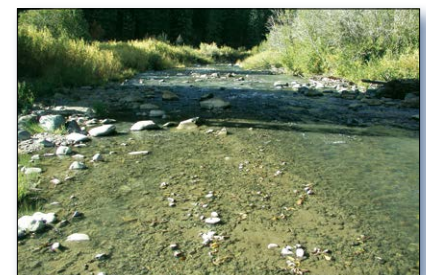
Figure 2. Before restoration, water diversion and land use activities caused the Lower Rio Blanco to be wide and shallow.

- Fortifying the streambanks by installing grade control structures and native material revetment (permanent structures composed of natural materials to protect eroding banks)
- Deepening the channel to decrease the stream width-to-depth ratio, which in turn decreases water temperature and improves the river's sediment transport capacity

- Restoring stream meanders, which offers greater physical stability
- Installing rock weirs (channel-spanning rock structures) and cross vanes to redistribute the stream energy away from the banks and toward the center of the stream (Figure 3).

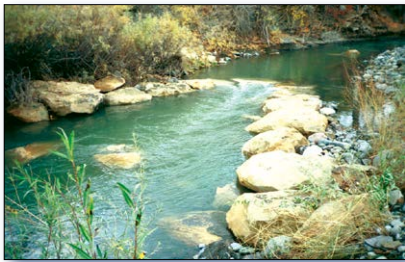
Figure 3. Project partners installed cross vanes and other stream channel stabilization BMPs.
