# NONPOINT SOURCE PROGRAM SUCCESS STORY

# Arkansas

## Implementing Agricultural Best Management Practices Reduces Turbidity in the St. Francis River

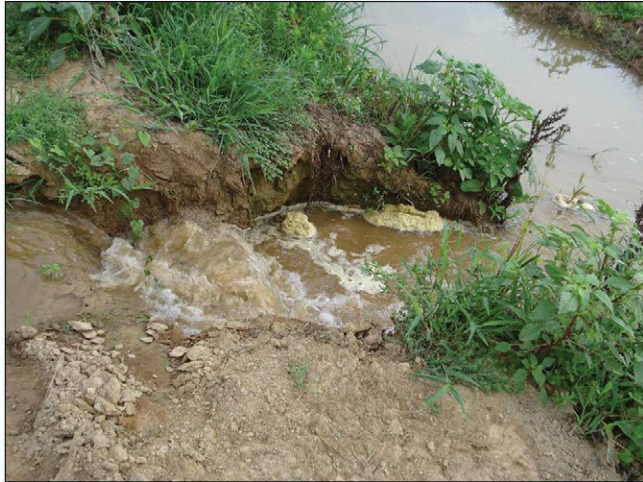
Figure 2. Erosion during agricultural runoff contributed sediment to the St. Francis River.

Erosion and siltation from agricultural row crop fields (Figure 2) contributed high levels of sediment to the river. ADEQ considers a stream reach in this planning segment (planning segment 5A) to be impaired by turbidity if more than 25 percent of all samples exceed 100 nephelometric turbidity units (NTU), based on 5 years of data before the assessment year. A 2006 ADEQ assessment found that stream reach 008 (55.9 miles long) and stream reach 009 (17.1 miles long) did not meet the water quality standard for turbidity. The 2006 assessment showed that 26 percent of the water samples from these two reaches exceeded 100 NTU for all flows, indicating that the river's aquatic life (fisheries) designated use was not being supported. Therefore, ADEQ added these two reaches to the state's 2006 CWA section 303(d) list of impaired waters for turbidity. ADEQ identified the source as agriculture.

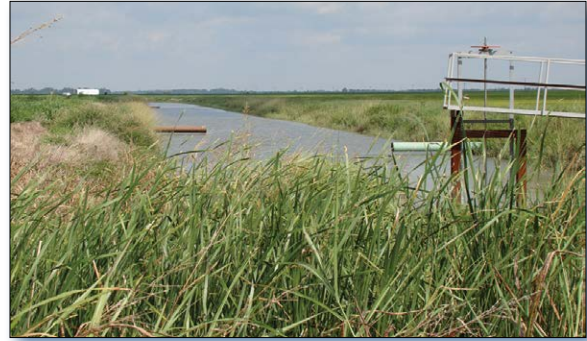
Figure 3. Landowners installed drop pipes that discharge runoff water directly into a waterbody to avoid erosion.

In 2009 the Cross County Conservation District (CCCD), using CWA section 319 funds provided by the Arkansas Natural Resources Commission (ANRC), began offering financial and technical assistance to help landowners implement water control structure BMPs called drop pipes (Figure 3). The BMPs prevent sediment from leaving agricultural fields by controlling the rate, velocity, and volume of field runoff. Many landowners took advantage of this opportunity; they installed 108 water control structures along with 10,120 feet of water transfer pipeline. In 2004 the CCCD used CWA section 319 funds to purchase a no-till drill that could be used by landowners with small agricultural operations. No-tilling allows for planting seed into the previous year's crop residue without any tillage. The crop residue protects the soil and lessens the opportunity for erosion. From 2004 through 2009, landowners used the drill to reduce erosion on more than 5,400 acres.
